TANK REFURBISHMENT

EFFLUENT TANK, CONFECTIONERY FACTORY

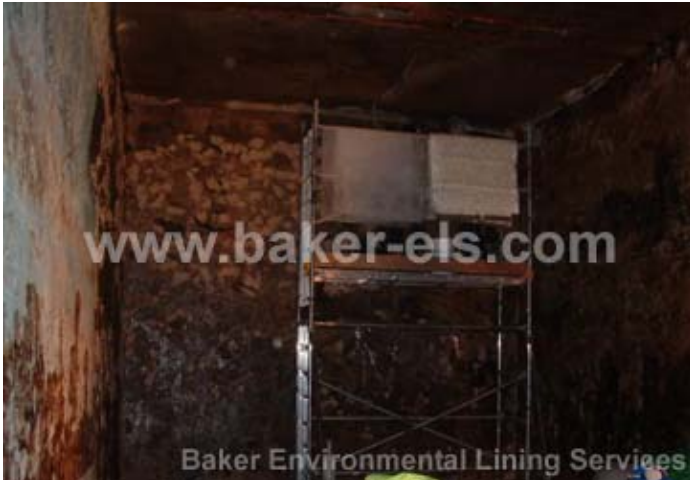
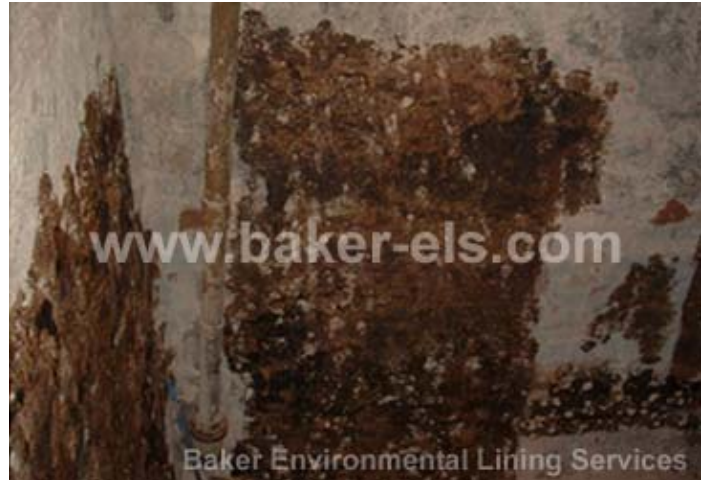
This 250m² underground effluent tank had suffered serious corrosion due to the high level of glucose, starch and fats.

The tank was ultra high pressure jet washed and all contaminants removed. It was dried by implementing indirect fired heaters and air movers. Once completely dry the walls and floor were repaired in several places using resin concrete. All areas were primed and allowed to cure.
