BUND REFURBISHMENT

CONCRETE BUND, NORTHERN ENGLAND

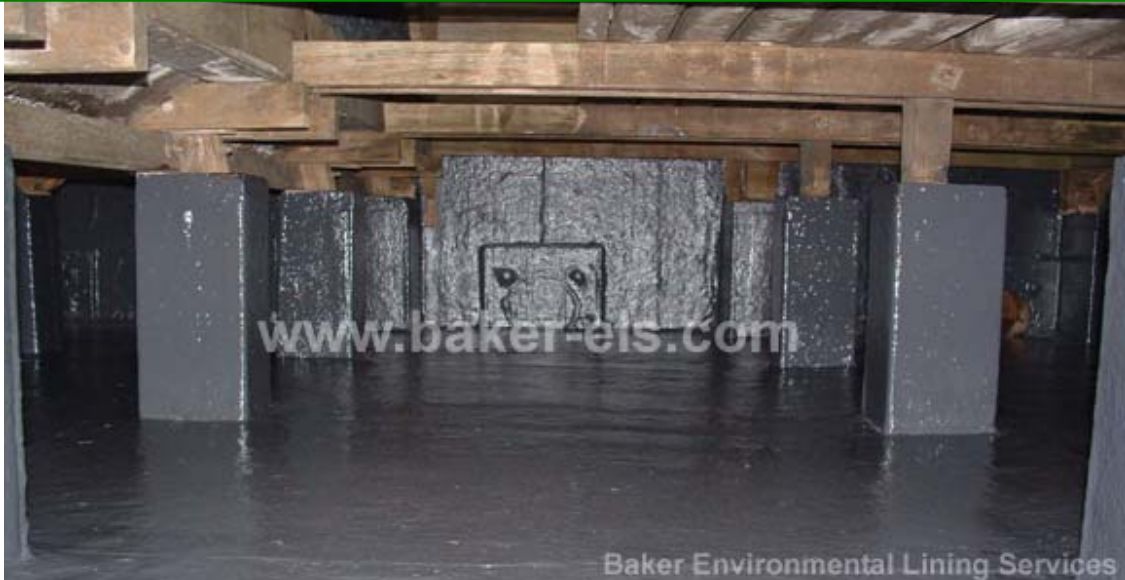
The clients water cooling tower was leaking through the concrete base causing too much water to be lost which in turn created obvious problems with the system.

The containment area was grit-blasted to ensure a correctly prepared surface ready to receive the lining system was achieved.

A damaged areas within the containment area were repaired implementing resin concrete.

A GRP lining system was recommended for the project as the client required a long-term solution to this problem.

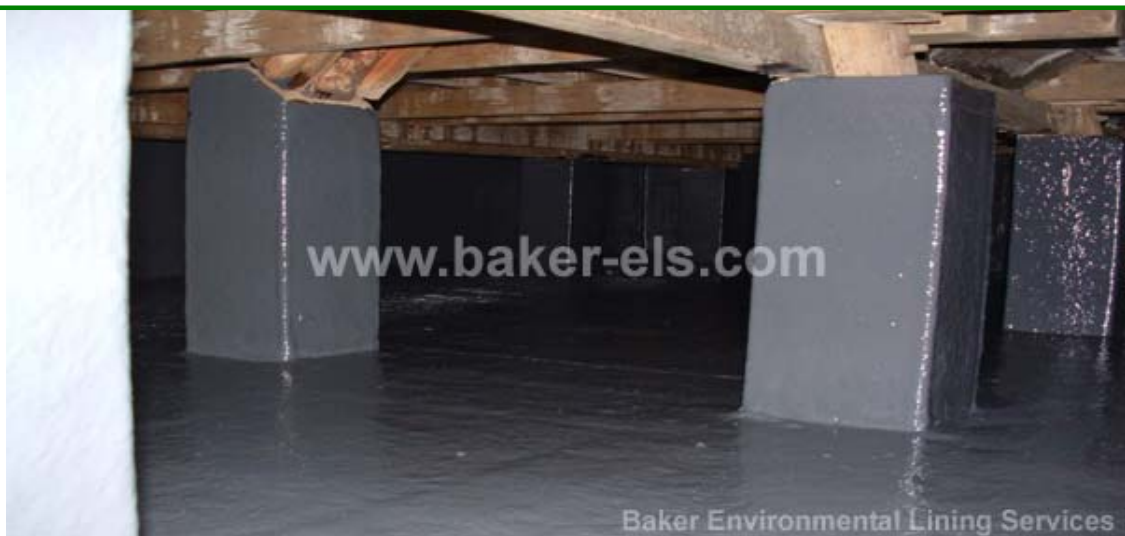
The lining system was applied to leave a strong, resilient system which has an easy clean ceramic like finish.
