TANK REFURBISHMENT

We were awarded an extensive refurbishment contract by an international fertilizer manufacturer.

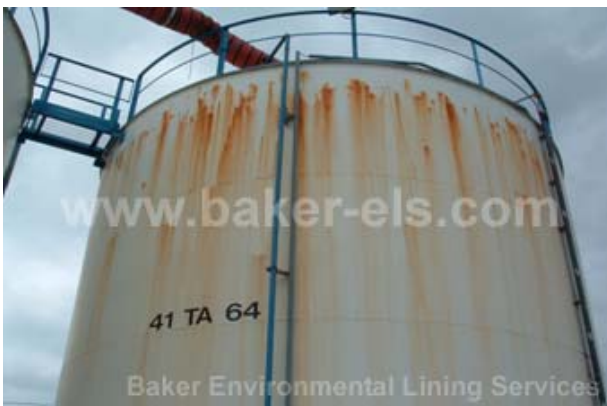
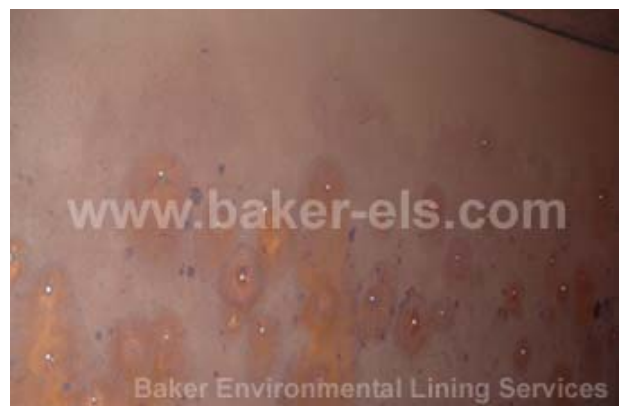
The project involved the complete refurbishment of nine large fertilizer storage tanks. The tanks were in a poor condition, many with numerous holes as displayed in pictures 1 & 2. The internal of the tanks were encrusted with solidified fertilizer which was 25mm thick in places (Picture 3).

Once the scaffolding had been erected internally the solidified fertilizer had to be manually removed from the tanks. The tanks were then grit blasted to remove all remaining residue and rust to leave a surface profile which would ensure optimum adherence of our lining system. This proved to be a lengthy process as over many years the fertilizer had entirely compacted on the walls.

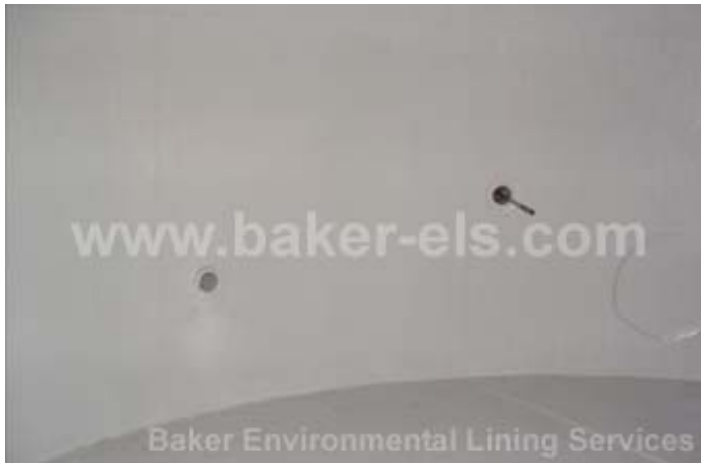
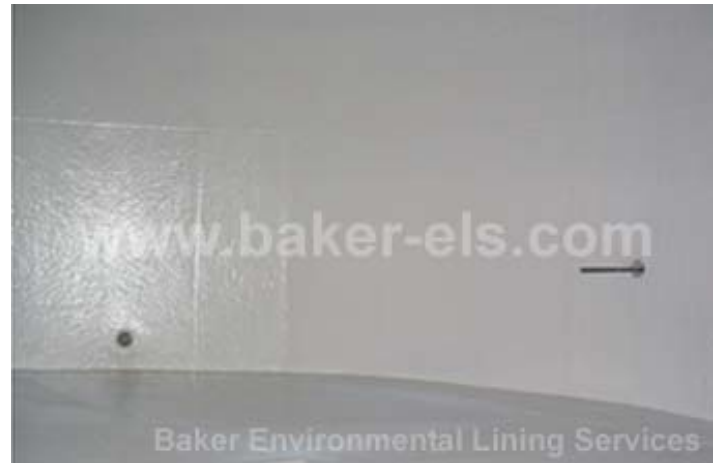
The tanks were primed with resin and a layer of fibreglass mat was applied to the prepared and primed surfaces. A chemical resisting tissue veil was also applied to ensure a pinhole free lining system. An extra layer of fibreglass was applied to the heavily pitted and holed areas to give a lining thickness of 6mm.

A resin wash was applied to all lined surfaces and again left to cure. This layer highlighted any surface irregularities which were sanded back to a smooth surface in readiness for the top coat.

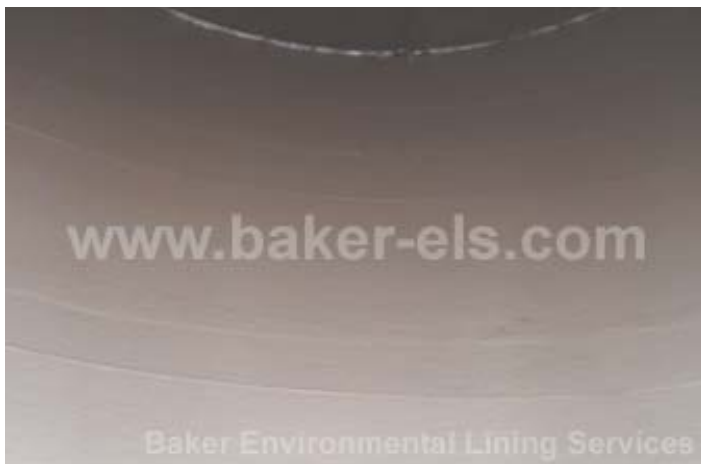
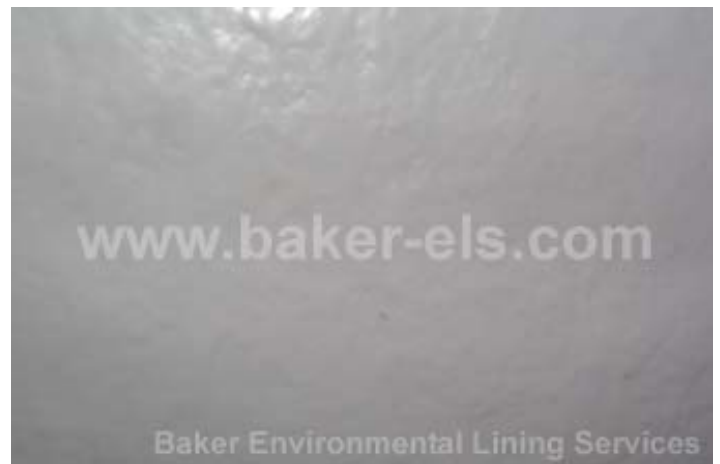
The top coat was then applied to leave a smooth, durable and seamless finish.

The project was a complete success.
