DIESEL BUND LINING

We were awarded the project of refurbishing and applying a lining system to numerous sites for a regional water authority.

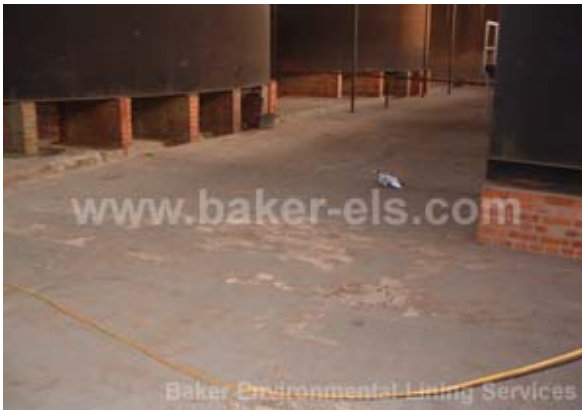
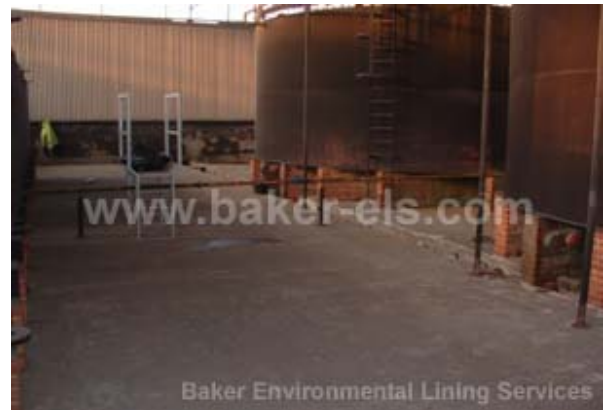
The bund pictured was a large bund of 631m² with several tank support plinths.

The bund was cleaned and then grit-blasted to ensure an excellent bond would be achieved between the substrate and the lining system.

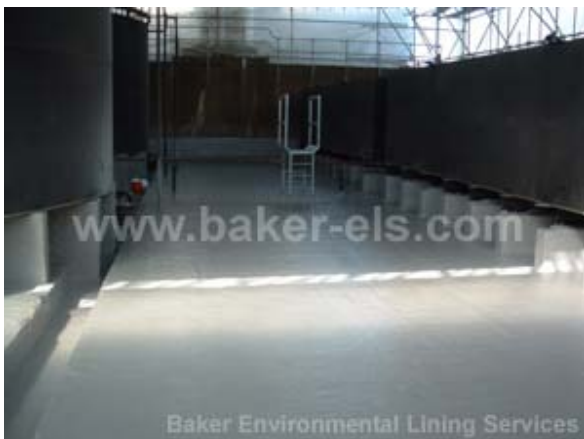
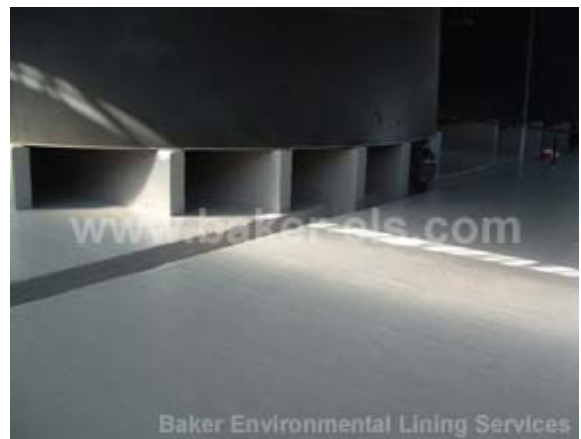
A 3mm GRP (glass reinforced plastic) lining system was applied to the bund and plinths to ensure it would be strong, seamless, hard wearing and long lasting.

It was determined that once lined a bund of this size would obviously retain a large amount of rain water. Due to this fact a Bundguard was installed to remove water without human intervention.
