TANK REFURBISHMENT

WASTE WATER STORAGE TANK – POULTRY FACTORY

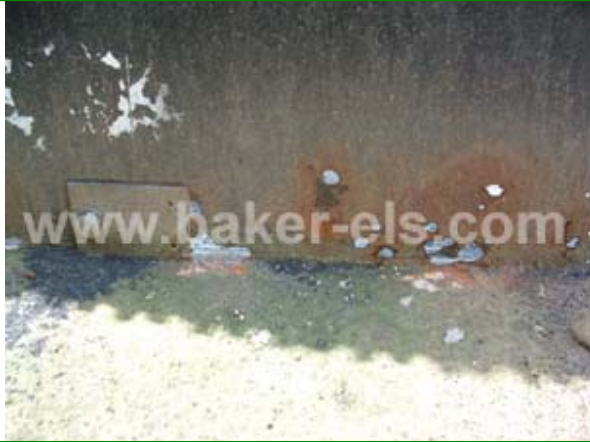
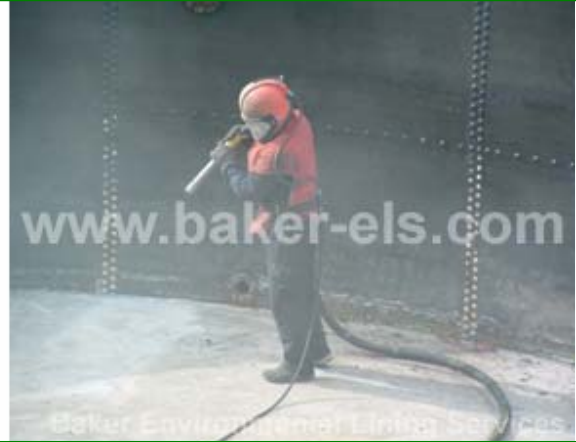
The waste water tank on this site was in very poor condition. There were numerous holes in the tank causing extensive leakage.

The tank was grit blasted to ensure all contaminants were removed and the correct profile was achieved to ensure optimum adherence of our lining system. Once all areas were grit blasted the tank was brushed and blown down and all debris and dust was removed.
