TANK REFURBISHMENT

WATER COOLING TANK LININGS – PAPER MILL

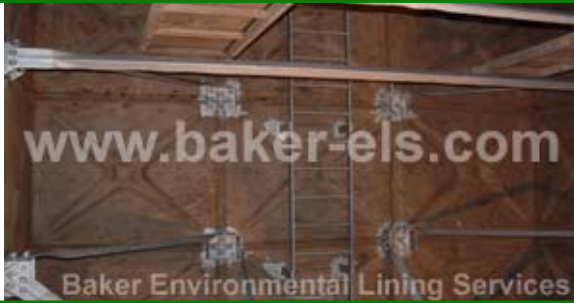
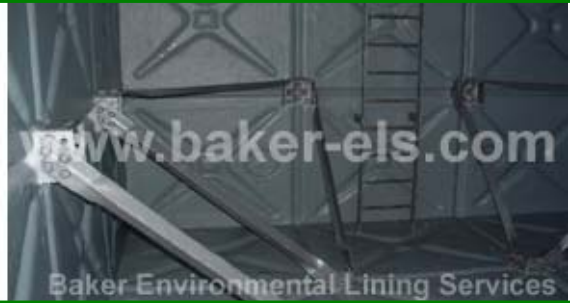
This tank had several holes and despite numerous attempts by others the leaks could not be stopped.

A two layer GRP lining system was specified as it is strong and durable, but is also flexible enough to move with the tank (a characteristic of a Braithwaite Tank). This tank was grit-blasted and cleaned internally. The GRP Lining System was applied to the walls and floor, whilst the ceiling and tie bars were coated in epoxy.

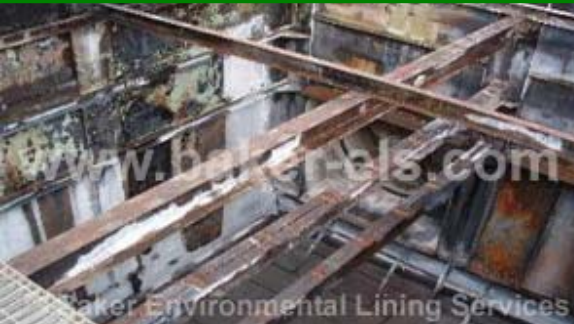
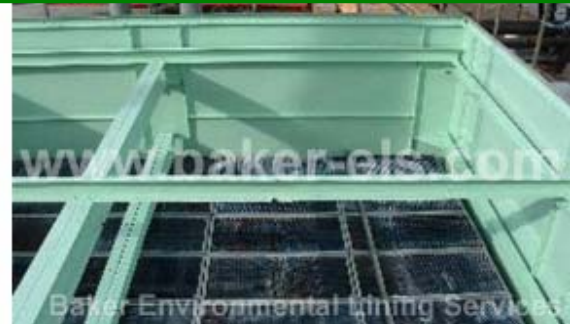
This welded steel water cooling tanks had corroded internally and needed to be refurbished to comply with the relevant standards. The tank was covered, dried and grit-blasted internally. An epoxy primer was spray applied to all prepared areas, followed by two coats of epoxy.

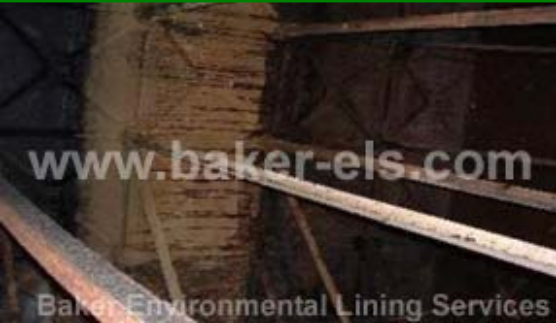
This tank had an existing rubber lining. The customer requested a GRP lining system but during technical survey it was determined that the existing lining could not easily be removed, and the time frame of the shutdown period would not allow such a task to be undertaken. We were not willing to apply a GRP lining over the rubber due to numerous incompatibility problems. We decided to carry out an adherence test using our rubber lining system. Once cured and despite our best efforts, the lining could not be removed from the original rubber lining – the adherence test proved to be successful.

The tank was high pressure jet washed to remove all contaminants and dried using air movers. All damaged areas were cut back and prepared. Two coats of our modified rubber lining system were spray applied to the tank.
