TANK REFURBISHMENT

BBC ATLANTIC RELAY STATION, ASCENSION ISLANDS

The project was to reinforce the base of a tank that had suffered corrosion and to apply a coving and protective coating to the external base of tank to protect from further corrosion.

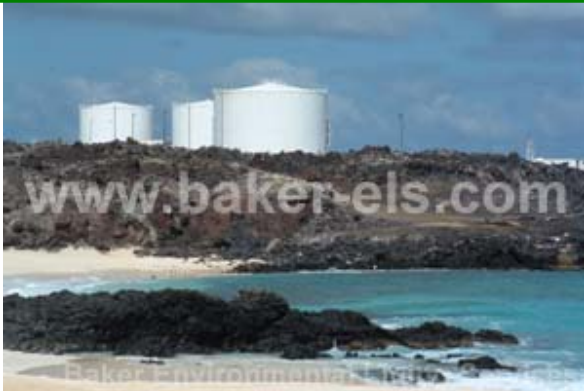
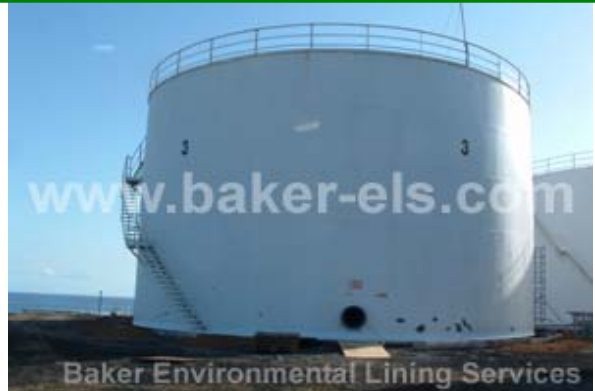
The tank floor and walls were grit blasted to the required height in preparation for the lining system.

A two layer GRP system was applied to the entire prepared area, and further layers were applied along the wall and floor joint to further reinforce the structure. A pigmented resin wash was applied and once cured, sanded back to leave a smooth surface for the final gel coating. The final coat was then applied to leave a smooth, durable and seamless finish.
